MAIN SWITCHBOARD				
Identification:		Main Switchboard 6		
Inspected By:		Lance Stewart		
Technician Signature:

Date:		20.03.17		
INSPECTION ITEMS

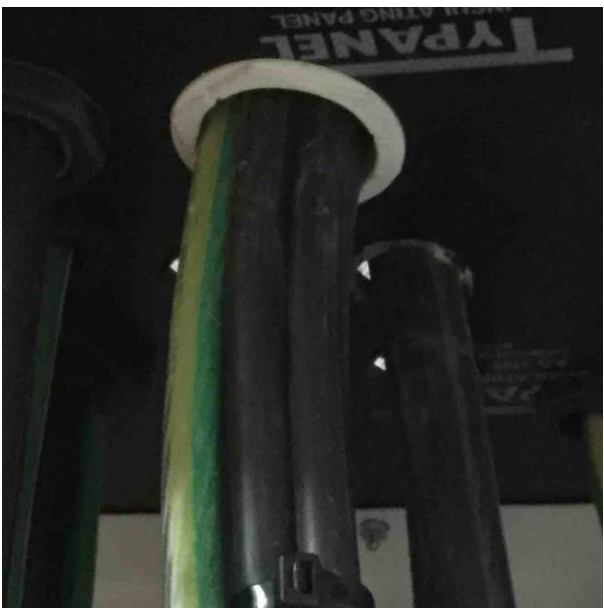
ITEM: 9	NON-COMPLIANCE

ITEM: 5	P1	Currently within the switchroom a resuscitation (CPR) chart and/or emergency procedure chart does not exist
ITEM: 9	P3	Penetration(s) are not sealed with openings greater than 5mm, therefore effecting the main switchboards IP rating and fire preventative measures.

<p>Priority: P3</p> <p>Non-Compliance: Penetration(s) are not sealed with openings greater than 5mm, therefore effecting the main switchboards IP rating and fire preventative measures.</p> <p>Legislation: AS/NZS 3000:2007/Amdt 2:2012: Clause 2.9.7 & 3.9.1 AS/NZS 3439.1:2002: Clause 7.1.3.6 & 7.8.3.3</p> <p>Recommendation/ Rectification: It is recommended the associated penetration(s) be sealed (fire retardant substance). This can be achieved via silicon (For cable glands), Foam filler (Cable penetrations), bungs etc.</p> <p>Site Specific Notes: Far cable zone on RHS. 4 x cable penetrations not sealed</p>

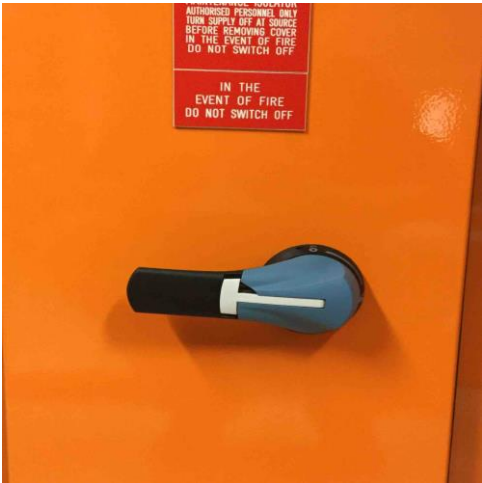
ITEM: 11	NON-COMPLIANCE

ITEM: 11	P4	Main switchboard equipment (Handles, locking facilities, escutcheon fixings, quarter turns, dome nuts etc.) are missing/and or damaged.
ITEM: 15	P3	The installed service protection device has insufficient and or incorrect identification and labelling.

<p>Priority: P4</p> <p>Non-Compliance: Main switchboard equipment (Handles, locking facilities, escutcheon fixings, quarter turns, dome nuts etc.) are missing/and or damaged.</p> <p>Legislation: AS/NZS 3439.1:2002: Clause 7.1.1 & 7.4.3.2.2 AS/NZS 3000:2007/Amdt 2:2012: Clause 1.5.4.4</p> <p>Recommendation/ Rectification: All damaged/missing enclosure equipment is to be repaired and or replaced to ensure the enclosures design intent is being met.</p> <p>Site Specific Notes: House services maintenance isolator cover fixings</p>

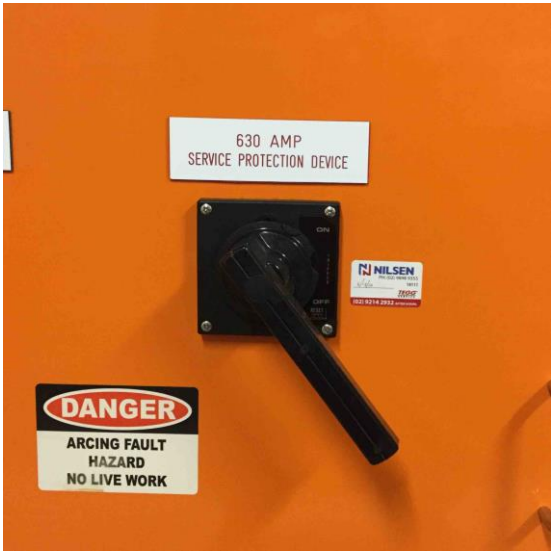
ITEM: 15	NON-COMPLIANCE

<p>Priority: P3</p> <p>Non-Compliance: The installed service protection device has insufficient and or incorrect identification and labelling.</p> <p>Legislation: AS/NZS 3000:2007/Amdt 2:2012: Clause 2.3.3.4, 7.2.6.1/2 NSW Service Rules 2016: Clause 4.7.10, 4.7.11 & 4.21.2.2</p> <p>Recommendation/ Rectification: It is recommended that the current Service Protection Device be re-labelled and identified with the labels listed below: - SPD Settings (Frame Size /Max Setting/ Set at) - Consumer Mains size & type</p> <p>Site Specific Notes: Install Frame Size, max setting & current setting label Install label describing consumer main sizing (1 x 300mm / PH + N + 1 x 120mm E)</p>

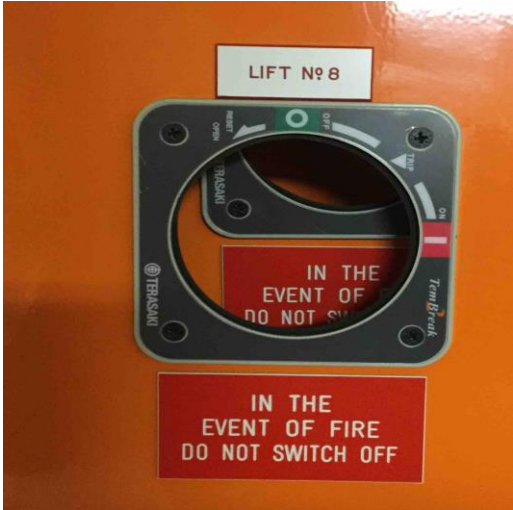
ITEM: 18	NON-COMPLIANCE

ITEM: 18	P3	The current equipment/service labelling does not sufficiently describe the current rating, submain size or type of the associated service.
ITEM: 18	P3	The current equipment/service labelling includes abbreviations, temporarily installed (hand written) and or is illegible.

<p>Priority: P3</p> <p>Non-Compliance: The current equipment/service labelling does not sufficiently describe the current rating, submain size or type of the associated service.</p> <p>Legislation: AS/NZS 3000:2007/Amdt 2:2012: Clause 2.9.5.2 NSW Service Rules 2016: Clause 4.21.1 & 4.21.2.6</p> <p>Recommendation/ Rectification: It is recommended that all associated equipment be re-labelled with suitable trifoliate labels identifying the current rating of the switchgear (Frame Size/Max Setting/Set at). The associated services requiring re-labelling are listed below:</p> <p>Site Specific Notes: Frame Size, max setting & current settings labels through. Qty of 8 required</p>

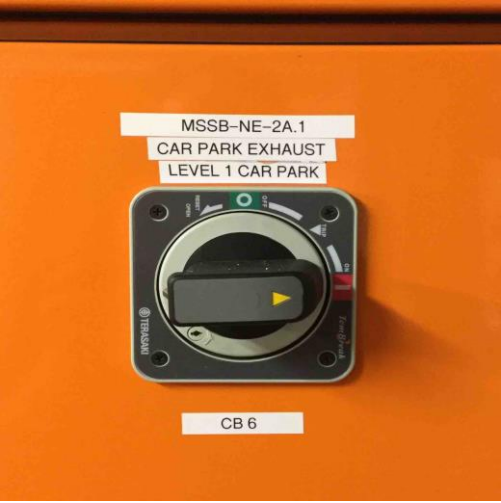
ITEM: 18	NON-COMPLIANCE

<p>Priority: P3</p> <p>Non-Compliance: The current equipment/service labelling includes abbreviations, temporarily installed (hand written) and or is illegible.</p> <p>Legislation: AS/NZS 3000:2007/Amdt 2:2012: Clause 2.9.5.1 & 2.9.5.2 NSW Service Rules 2016: Clause 4.21, 4.21.1 & 4.21.2.6</p> <p>Recommendation/ Rectification: It is recommended that all associated equipment be re-labelled with suitable trifoliate labels with full descriptions used with no abbreviations used. The associated services requiring re-labelling are listed below:</p> <p>Site Specific Notes: Temporary labelling throughout. CB 6 & 10</p>

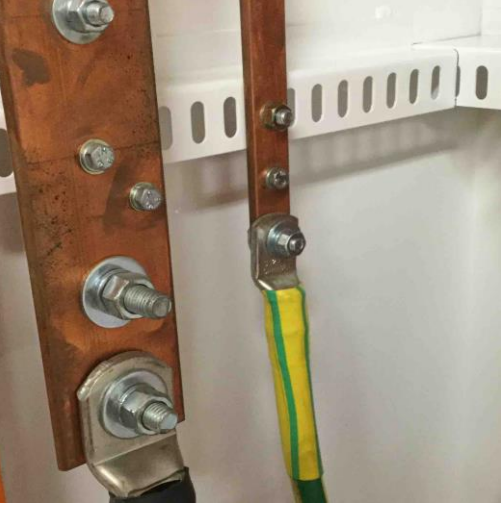
ITEM: 19	NON-COMPLIANCE

ITEM: 19	P3	The main earthing conductor installed within the main switchboard and its location has not been labelled/identified.
ITEM: 25	P3	The minimum bending radius for the installed cabling has been ignored damaging the cable.

<p>Priority: P3</p> <p>Non-Compliance: The main earthing conductor installed within the main switchboard and its location has not been labelled/identified.</p> <p>Legislation: AS/NZS 3000:2007/Amdt 2:2012: Clause 5.5.1.3</p> <p>Recommendation/ Rectification: It is recommended that a suitable trifoliate label be installed for the Main Earthing conductor and its location. "MAIN EARTH * LOCATED BEHIND" & "MAIN EARTH - DO NOT DISCONNECT"</p> <p>Site Specific Notes: Earth Conductor not labelled</p>

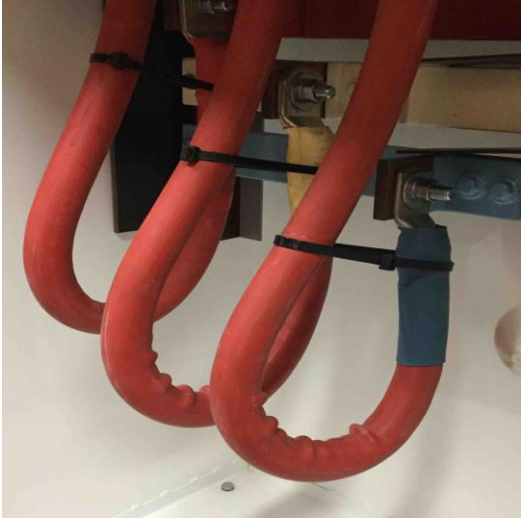
ITEM: 25	NON-COMPLIANCE

<p>Priority: P3</p> <p>Non-Compliance: The minimum bending radius for the installed cabling has been ignored damaging the cable.</p> <p>Legislation: AS/NZS 3000:2007/Amdt 2:2012: Clause 3.9.6</p> <p>Recommendation/ Rectification: It is recommended that associate cabling be replaced and or repaired. The cabling should be re-installed considering the minimum bending radius given by the cabling manufacturer.</p> <p>Site Specific Notes: Consumer mains bent beyond manufacturers standards. Damage evident. Cut and re-terminate - sub outage required</p>

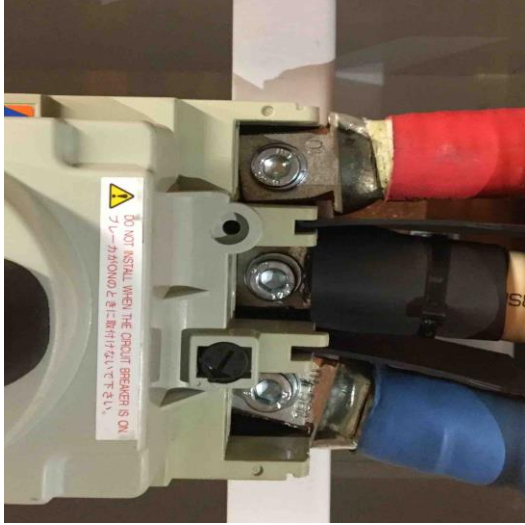
ITEM: 27	NON-COMPLIANCE

ITEM: 27	P1/P3	Stranded copper termination made without appropriate sleeving, lugs, bootlaces etc.
Item	Priority	General Recommendation
ITEM: 36	P1/P4	It is recommended that the existing consumer mains connections be wrapped with suitable heat shrink to provide insulation.

<p>Priority: P1/P3</p>
	<p>Non-Compliance: Stranded copper termination made without appropriate sleeving, lugs, bootlaces etc.</p>
	<p>Legislation: AS/NZS 3000:2007/Amdt 2:2012: Clause 3.7.2.5 AS/NZS 3439.1:2002: Clause 7.8.3.101</p>
	<p>Recommendation/ Rectification: It is recommended the associated termination be removed and re-terminated. The termination should be made with appropriate conductor sleeving, lugs and or bootlaces.</p>
	<p>Site Specific Notes: MSSB NE 2A.1. Lugs have trimmed to fit CB. Install appropriate CB LUGS</p>
